Modification to Modern Hydraulic Disk Brake Assembly to Improve Sliding Pin Function

This modification was discovered while trying to remove a seized caliper pin on a 2008 F-250.

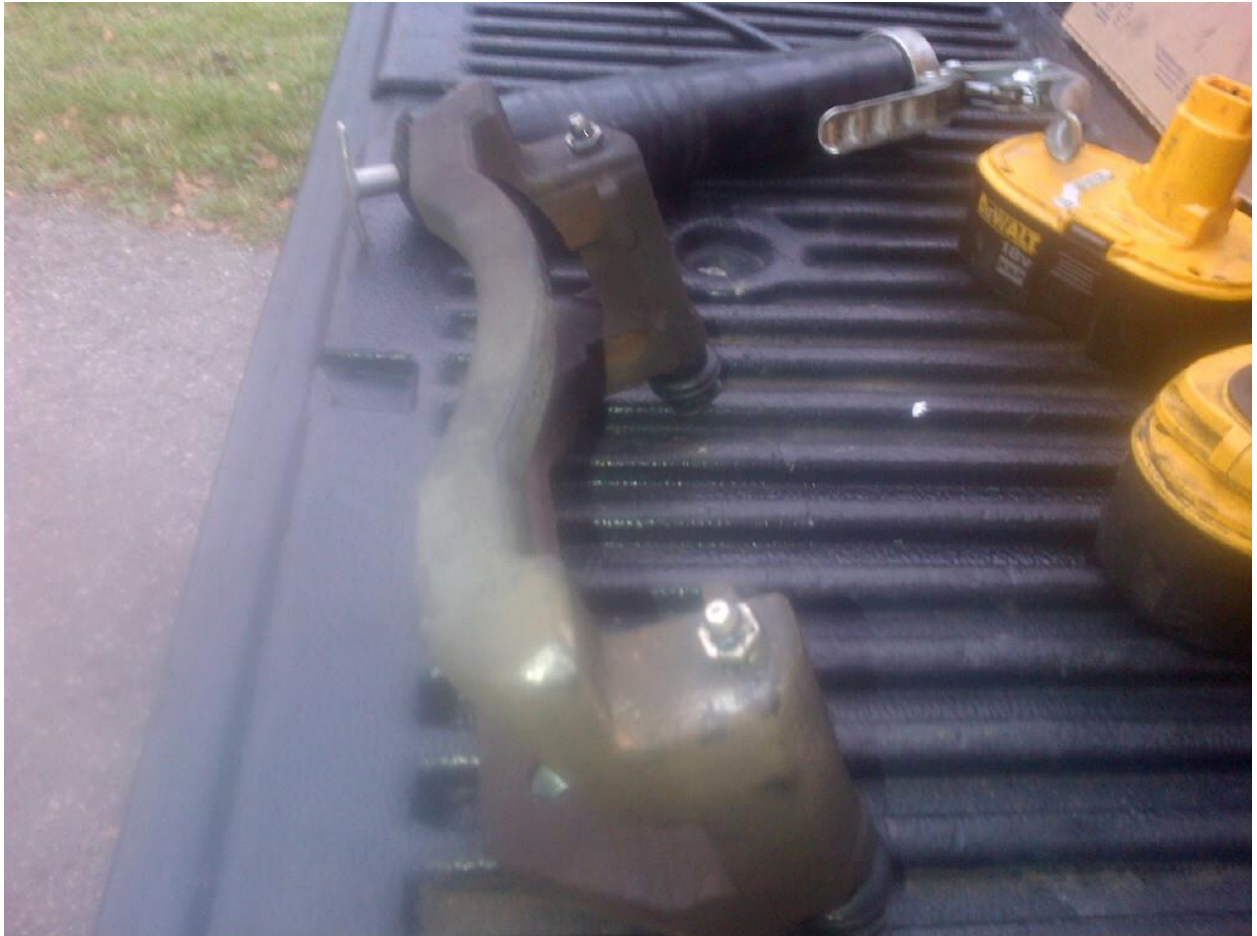
Picture #2

Caliper Mount Bracket with modification completed and grease zerks installed.

The hole that was drilled and tapped in communication with the pin bore for removal of the pin (See Drawing #4), although intended for a removal purpose, was also an excellent method of allowing periodic injection of lubrication to the pin/bore. With the ability to inject lubrication routinely, the pin is not allowed to become frozen by dirt and outside debris. Lubrication can be injected through the wheel without dismounting (See Picture #3). Currently the only method to maintain the pin lubrication is to fully disassemble wheel and caliper assembly to allow access to remove, clean and lubricate the pin. Although a simple solution, this has not been implemented in new, or replacement parts.

Routine injection of lubrication to the sliding pins will greatly reduce seized caliper sliding pins, increasing pad, rotor and caliper life. Not to mention a safer and more reliable brake assembly.

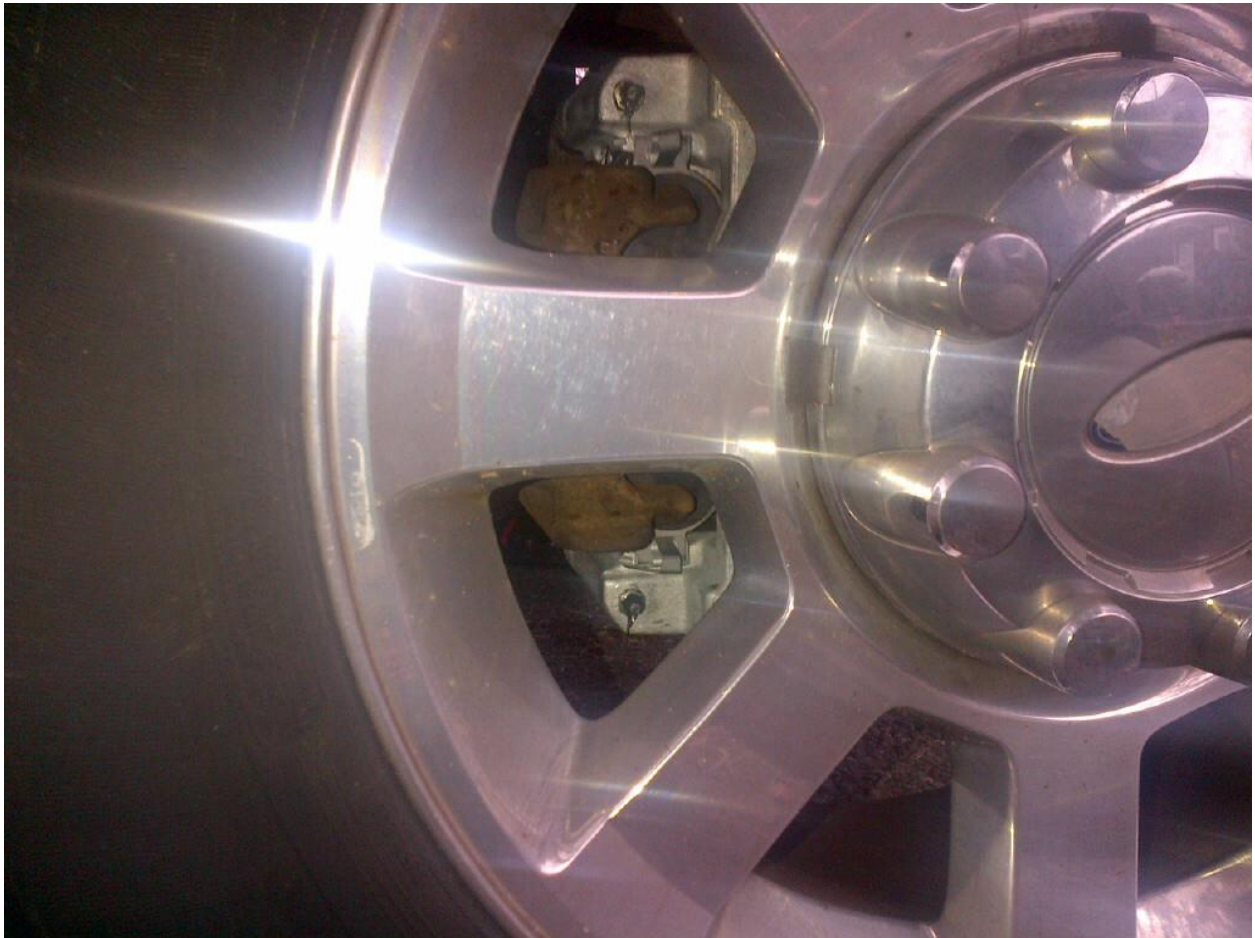
Picture #3

Injection zerks are easily assessable from outside without dismounting wheels. (2008 F-250)

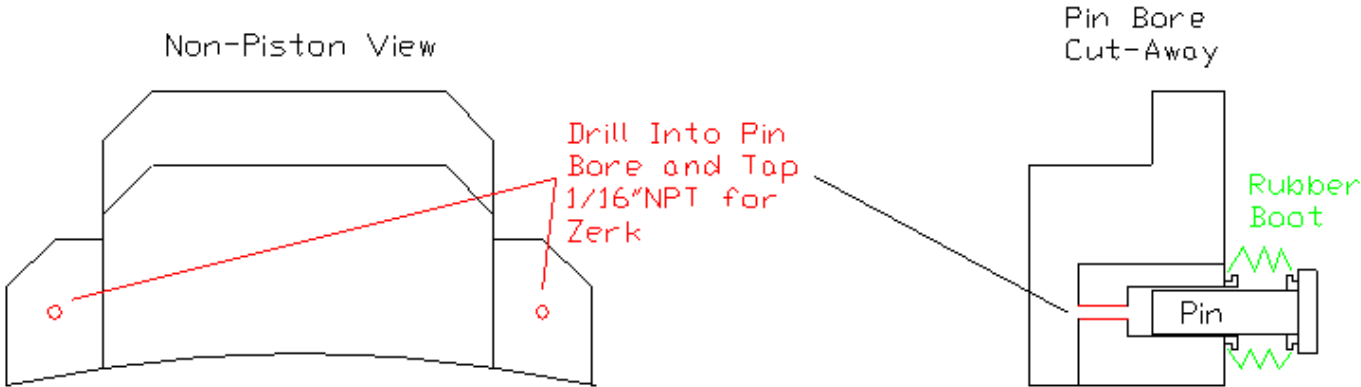
Picture #4

Drawing of lubrication passages in communication with pin/bores.
